NEW MEXICO ENVIRONMENT DEPARTMENT

Re: Industrial Storm Water; SIC 1021; NPDES Compliance Evaluation Inspection; Freeport McMoRan, Inc. Chino Mine, McCauley Limestone Quarry, NMU001916, April 13, 2016

NPDES Industrial Storm Water Checklist (MSGP)

ATTACHMENT D-2
100-YEAR, 24-HOUR STORMWATER CALCULATIONS
(Telesto Solutions, Inc.)

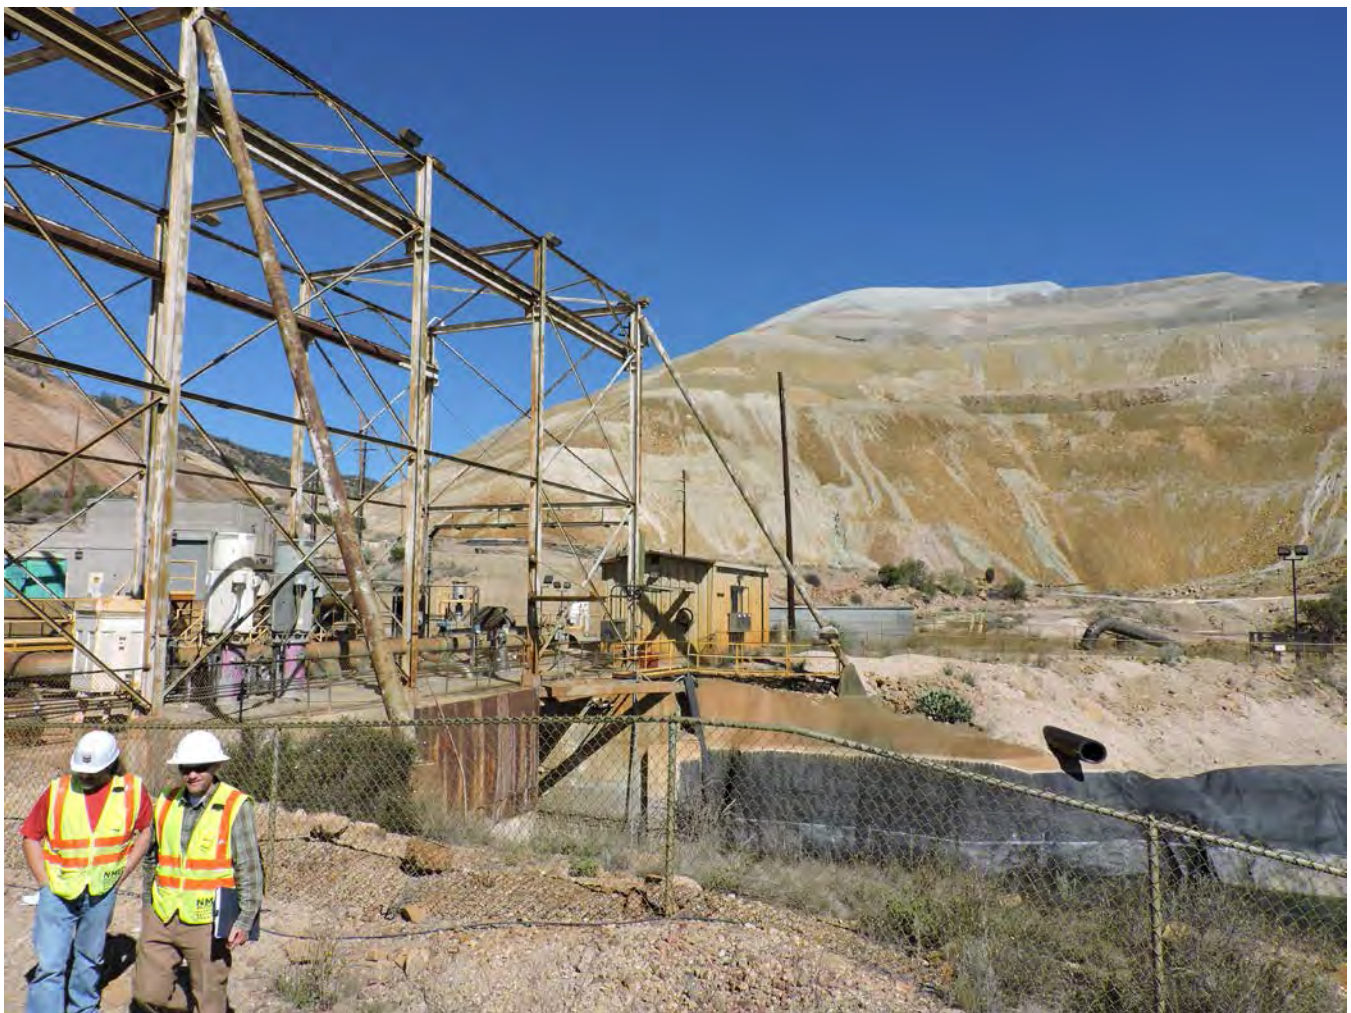
Official Photograph Log
Photo # 1

Photographer: Christian Krueger, FMI	Date: 4-13-16	Time: 1034 hours
City/County: Hurley, Grant County		
Location: Freeport McMoRan, Inc., Chino Mine		
Subject: Lampbriht Stockpiles and retention basins.

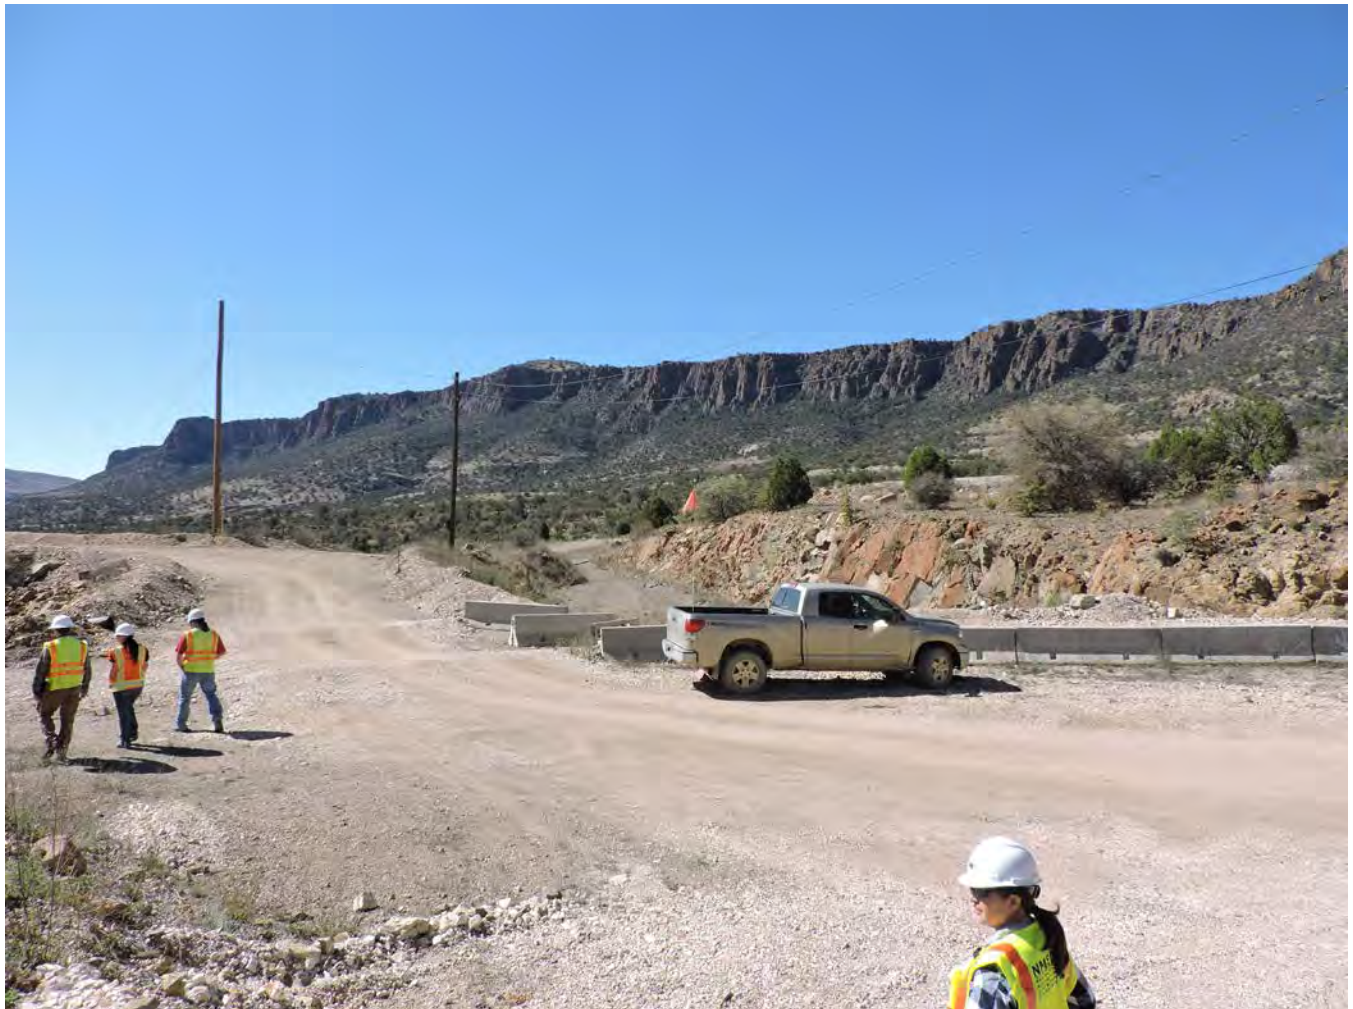
Photo # 2

Photographer: Christian Krueger, FMI	Date: 4-13-16	Time: 1034 hours
City/County: Hurley, Grant County		
Location: Freeport McMoRan, Inc., Chino Mine		
Subject: Discharge structure from the Lampbright retention basins. Water would overtop the road and then be discharged into the channel behind the truck in the photo. The channel is equipped with a French drain system, where the flow is routed to the Dam #8 seep collection system.

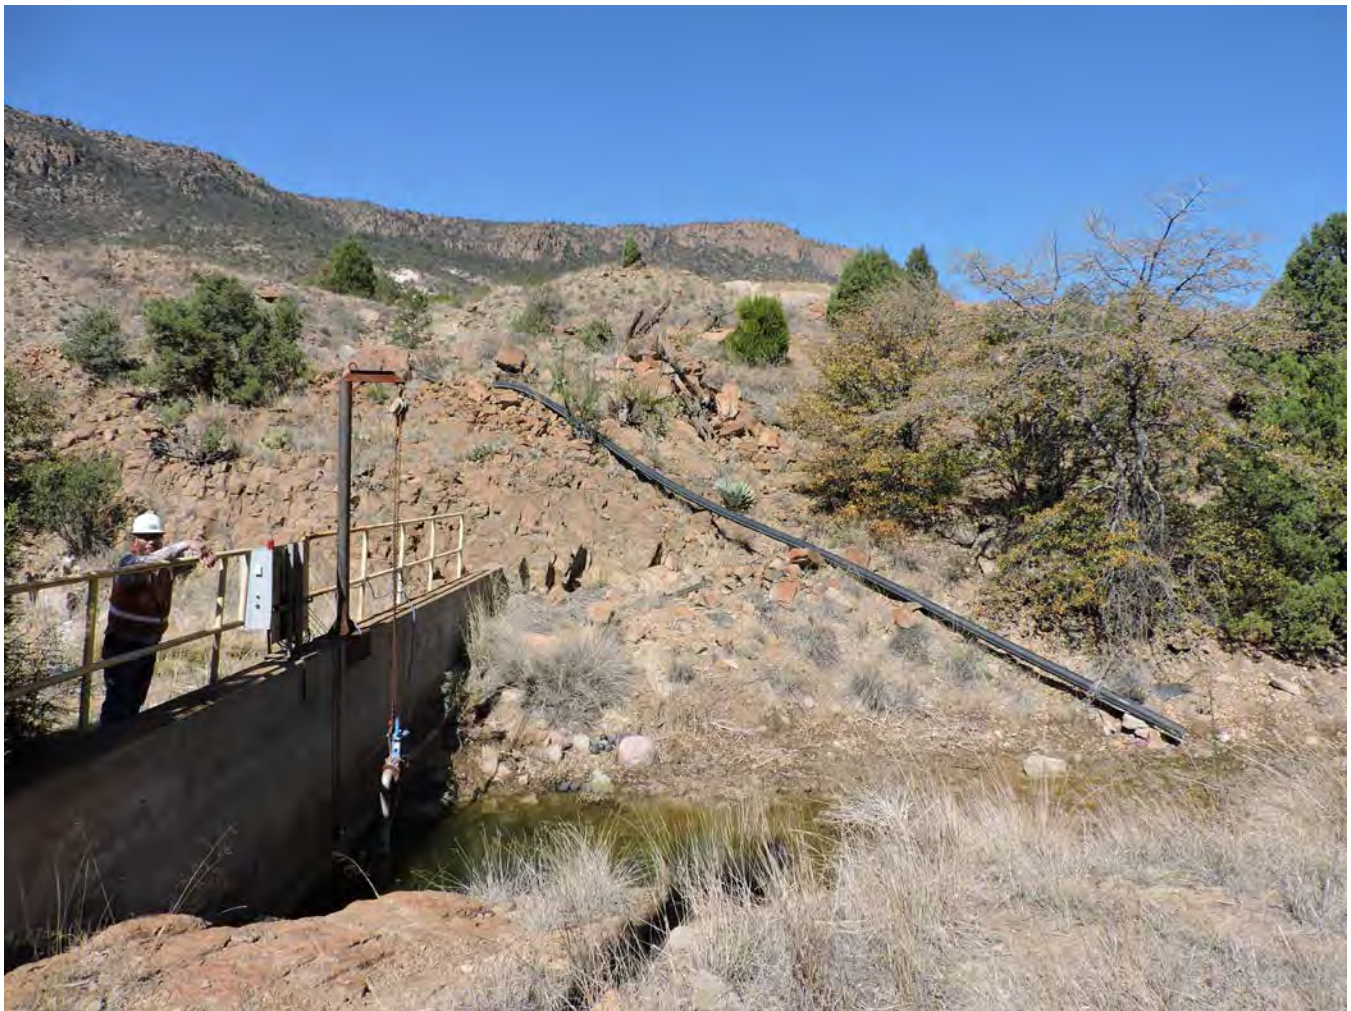
Photo # 3

Photographer: Christian Krueger, FMI	Date: 4-13-16	Time: 1045 hours
City/County: Hurley, Grant County		
Location: Freeport McMoRan, Inc., Chino Mine		
<p>Subject: Dam #8 seep collection system. The pipe directed down the side of the hill would route flows from the channel seen in Photo #2 to this area for pumping back to the retention basins behind Dam #8. Routine inspections are conducted by the Hydromet staff daily. The pump is equipped with an audible and visual alarm but there is no callout to a central dispatch location.</p>

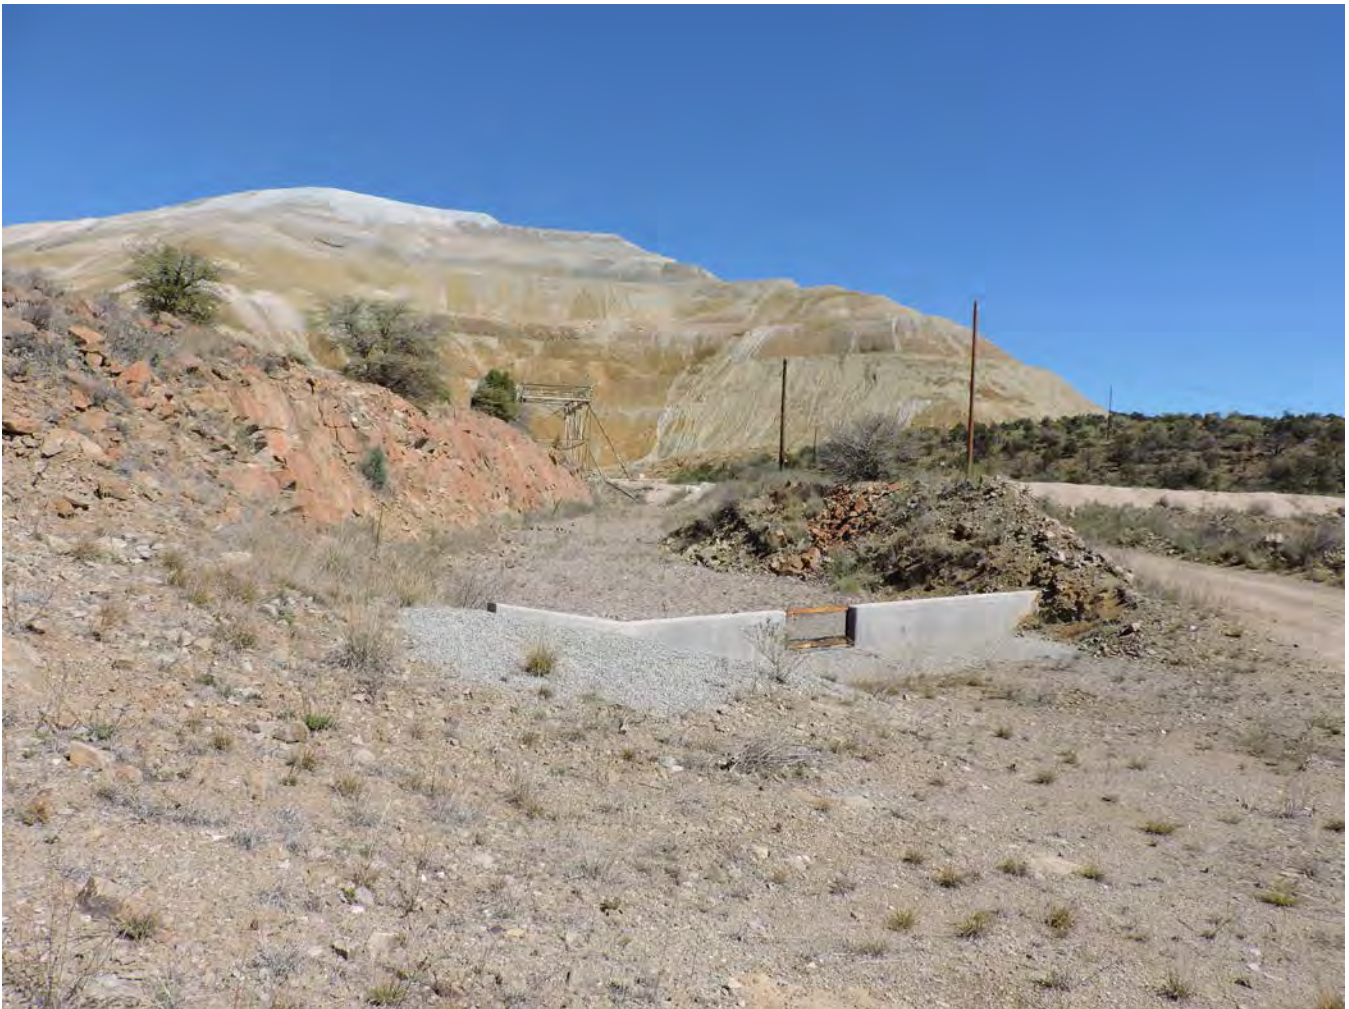
Photo # 4

Photographer: Christian Krueger, FMI	Date: 4-13-16	Time: 1103 hours
City/County: Hurley, Grant County		
Location: Freeport McMoRan, Inc., Chino Mine		
Subject: Lampbright Stockpiles and French drain system located prior to discharge to Lampbright Draw.

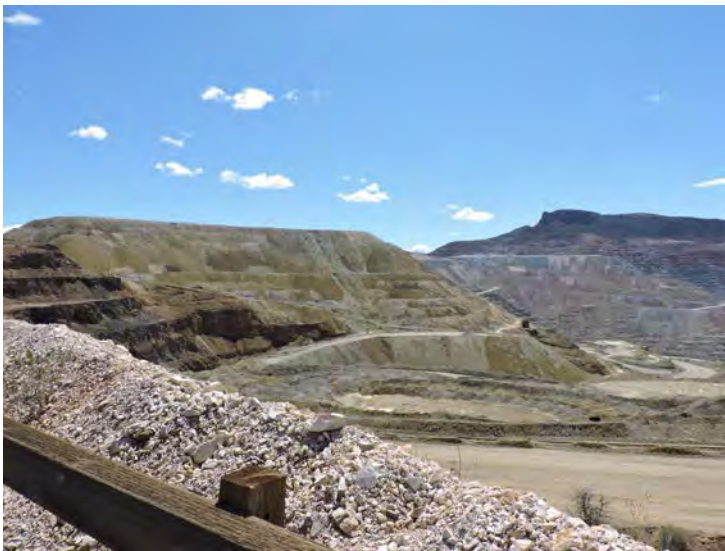
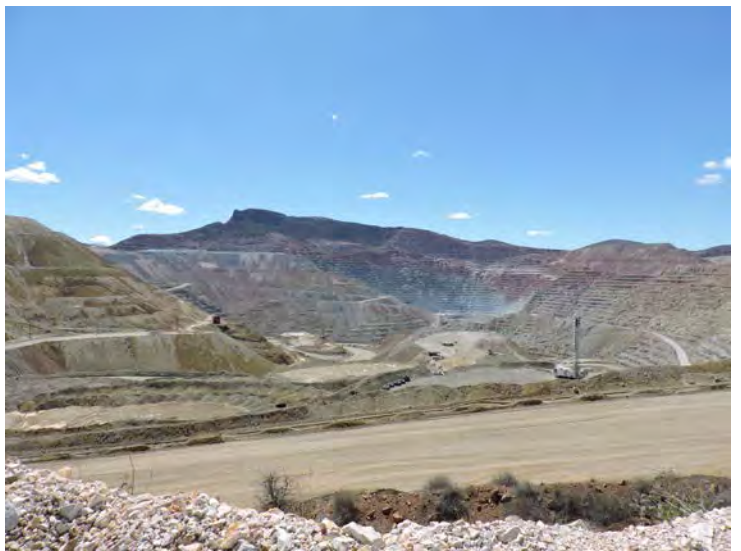
Photo # 5 & 6

Photographer: Christian Krueger, FMI	Date: 4-13-16	Time: 1139 hours
City/County: Hurley, Grant County		
Location: Freeport McMoRan, Inc., Chino Mine		
Subject: Overview of the Santa Rita Pit.

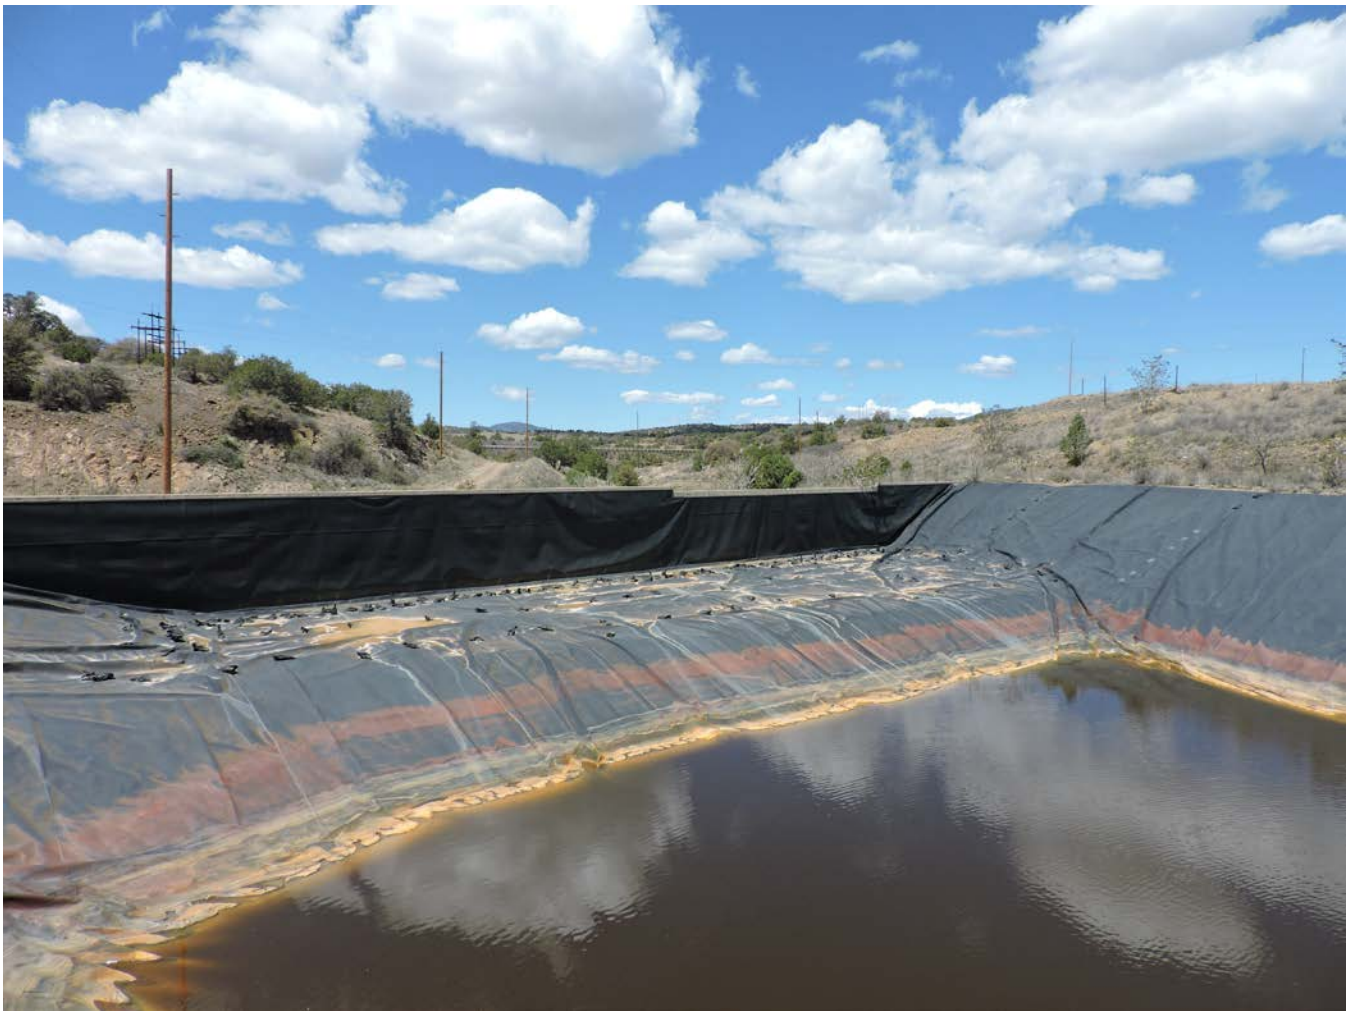
Photo # 7

Photographer: Christian Krueger, FMI	Date: 4-13-16	Time: 1307 hours
City/County: Hurley, Grant County		
Location: Freeport McMoRan, Inc., Chino Mine		
Subject: Retention basin below the Ivanhoe concentrator. (Former Outfall 002 under NM0020435)

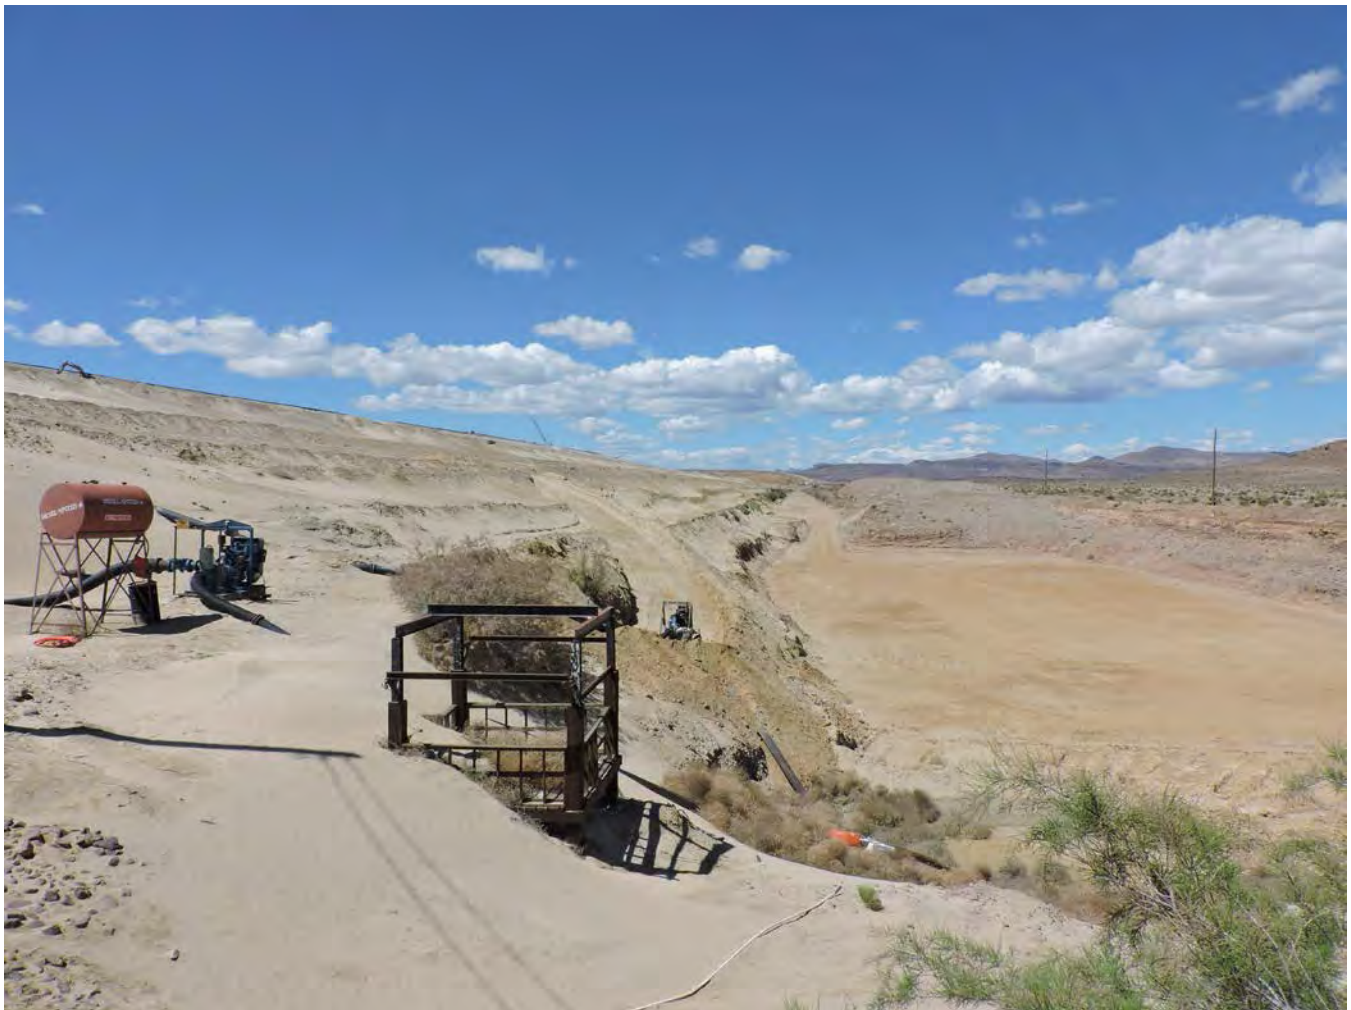
Official Photograph Log
Photo # 8

Photographer: Christian Krueger, FMI	Date: 4-13-16	Time: 1435 hours
City/County: Hurley, Grant County		
Location: Freeport McMoRan, Inc., Chino Mine		
Subject: Stormwater outfall SWTP-3 at the southern end of the tailings ponds (south of the only active tailing facility).

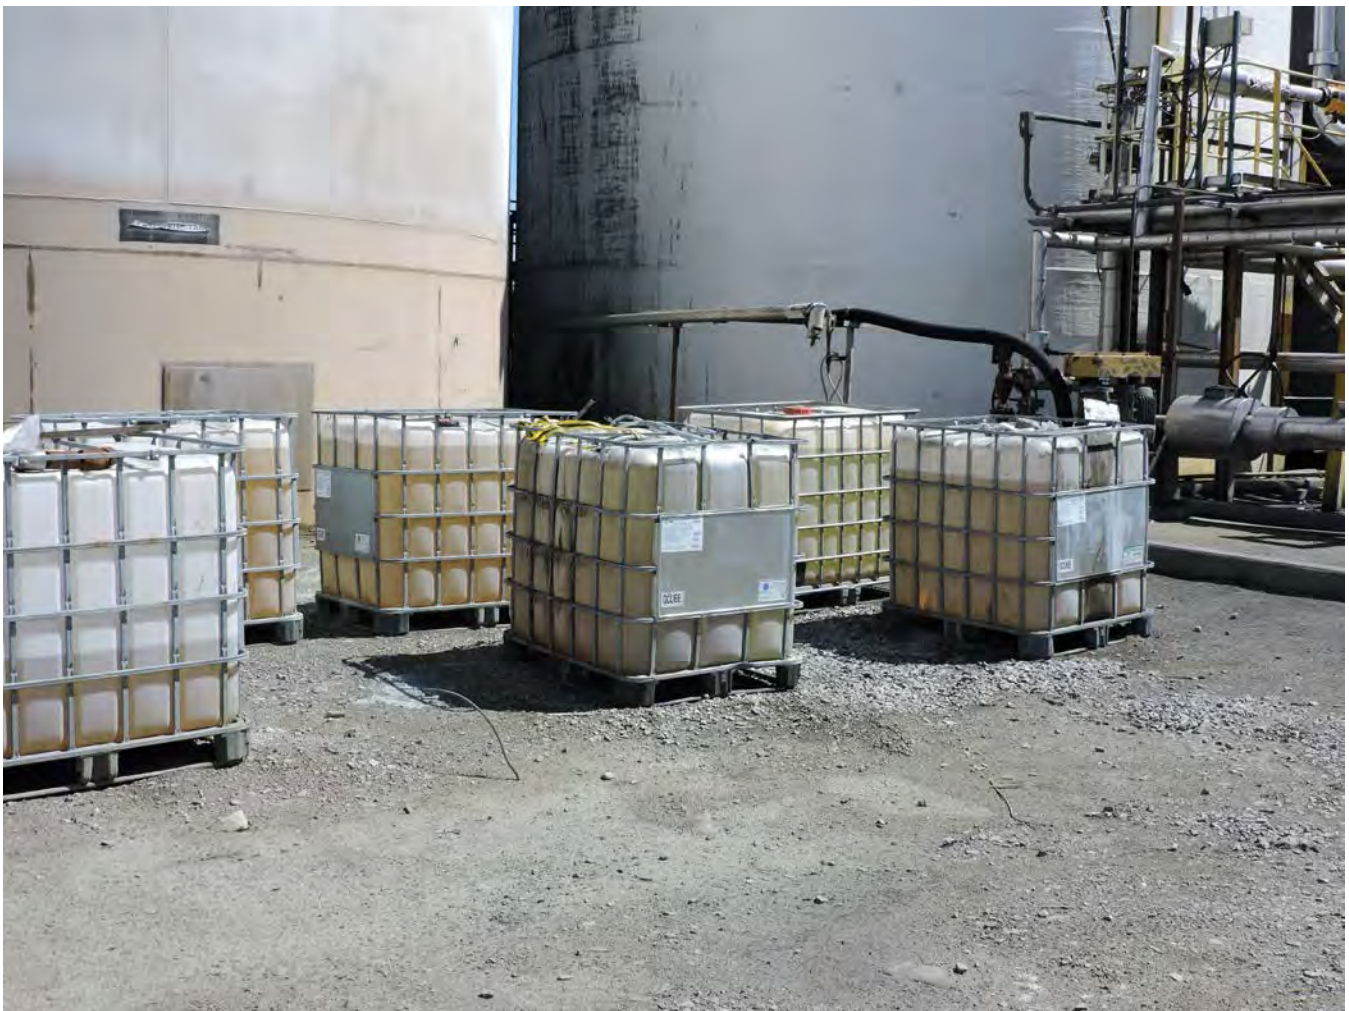
Photo # 9

Photographer: Christian Krueger, FMI	Date: 4-13-16	Time: 1307 hours
City/County: Hurley, Grant County		
Location: Freeport McMoRan, Inc., Chino Mine		
Subject: Freestanding totes of flocculent located at the filter plant. No secondary containment was present.

Does the SWPPP include procedures for minimizing the potential for leaks, spills and other releases that may be exposed to storm water and develop plans for effective response to such spills if or when they occur?	<input checked="" type="checkbox"/> Y <input type="checkbox"/> N	
Does the facility implement procedures for plainly labeling containers (e.g., "Used Oil," "Spent Solvents," "Fertilizers and Pesticides," etc.) that could be susceptible to spillage or leakage to encourage proper handling and facilitate rapid response if spills or leaks occur?	<input checked="" type="checkbox"/> Y <input type="checkbox"/> N	
Does the facility implement preventative measures such as barriers between material storage and traffic areas, secondary containment provisions, and procedures for material storage and handling?	Y <input type="checkbox"/> N <input checked="" type="checkbox"/>	Secondary containment needed for flocculent totes stored at the filter plant. Lime storage at the filter plant also needs to be moved or covered.

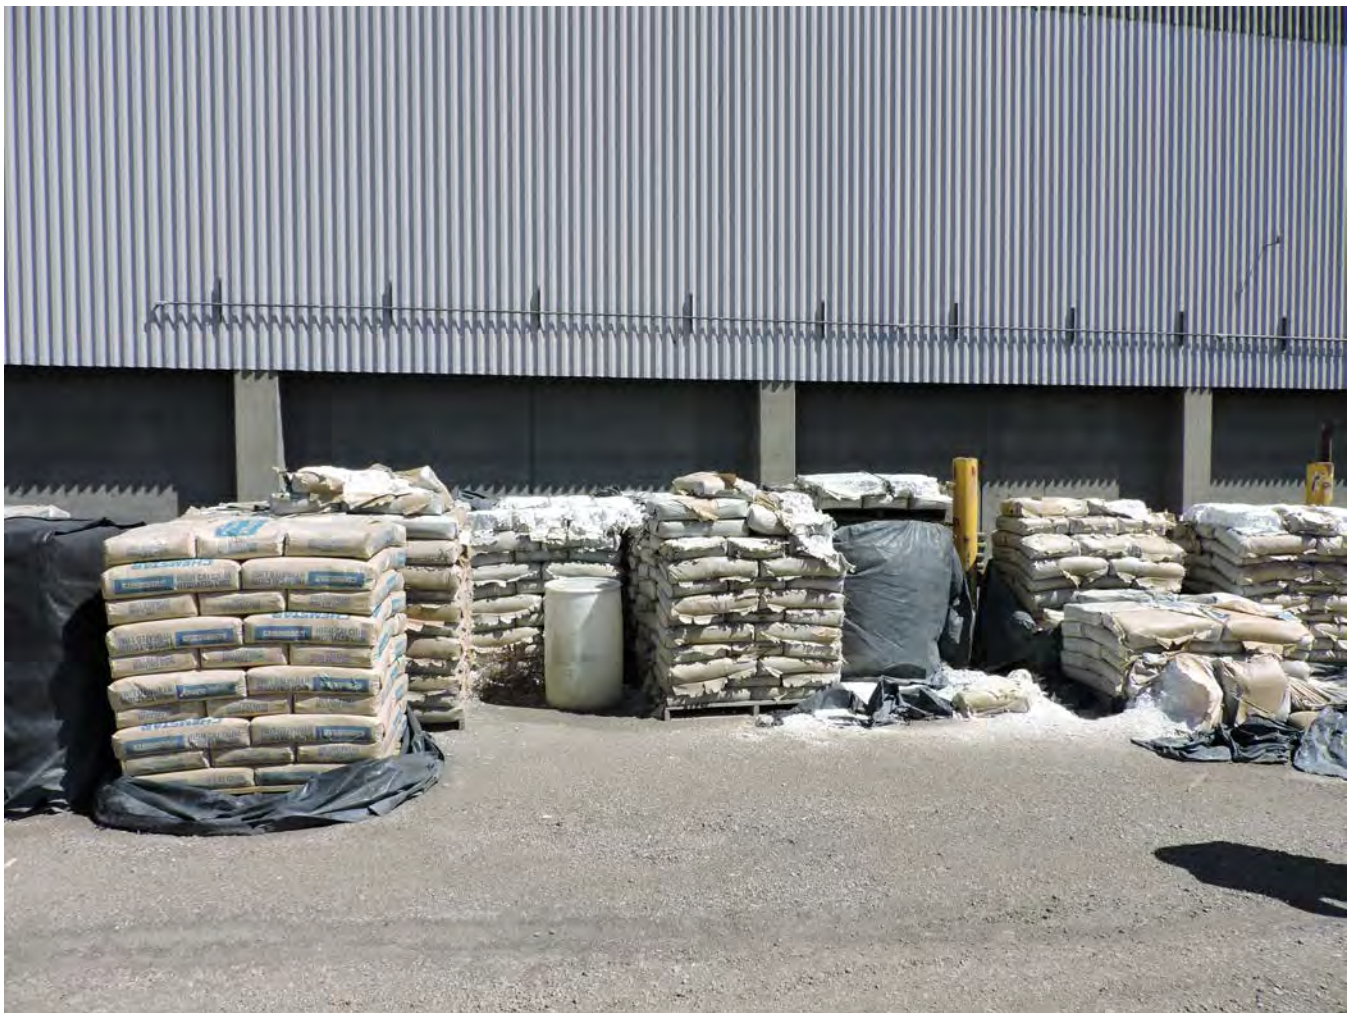
Photo # 10

Photographer: Christian Krueger, FMI	Date: 4-13-16	Time: 1507 hours
City/County: Hurley, Grant County		
Location: Freeport McMoRan, Inc., Chino Mine		
Subject: Outdoor lime storage at the filter plant. No cover was available for this area.

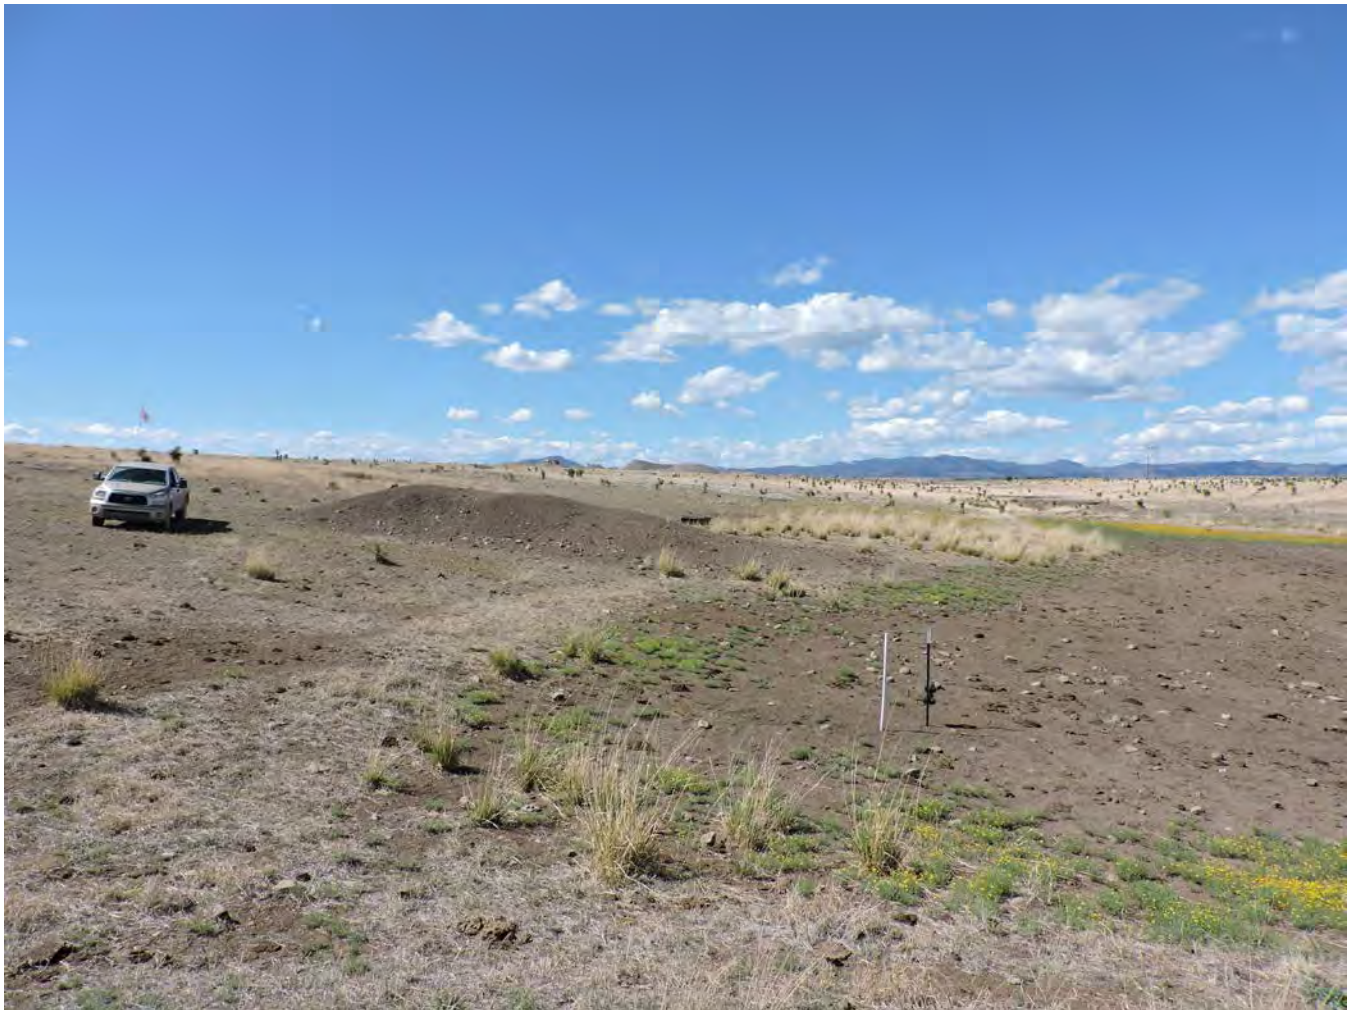
Photo # 12

Photographer: Christian Krueger, FMI	Date: 4-13-16	Time: 1608 hours
City/County: Hurley, Grant County		
Location: Freeport McMoRan, Inc., Chino Mine		
Subject: SWLQ-3, sampling location for the quarry discharge under Sector J. Sampling location was in-stream and could be diluted by upstream flows. Recommendation was made to move the sample location back upstream to previous location and focus on BMP implementation at the quarry area. Photo was taken standing on top of berm in the channel.

The sampling location for the quarry (SWLQ-3) had been moved from its previous location (closer to the quarry) to the top of the dam located in an unnamed tributary to Apache Tejo. By locating the sampling location within the receiving waterbody, dilution of the flow is present and could alter the results. Sampling locations must be located outside of the receiving waterbody.

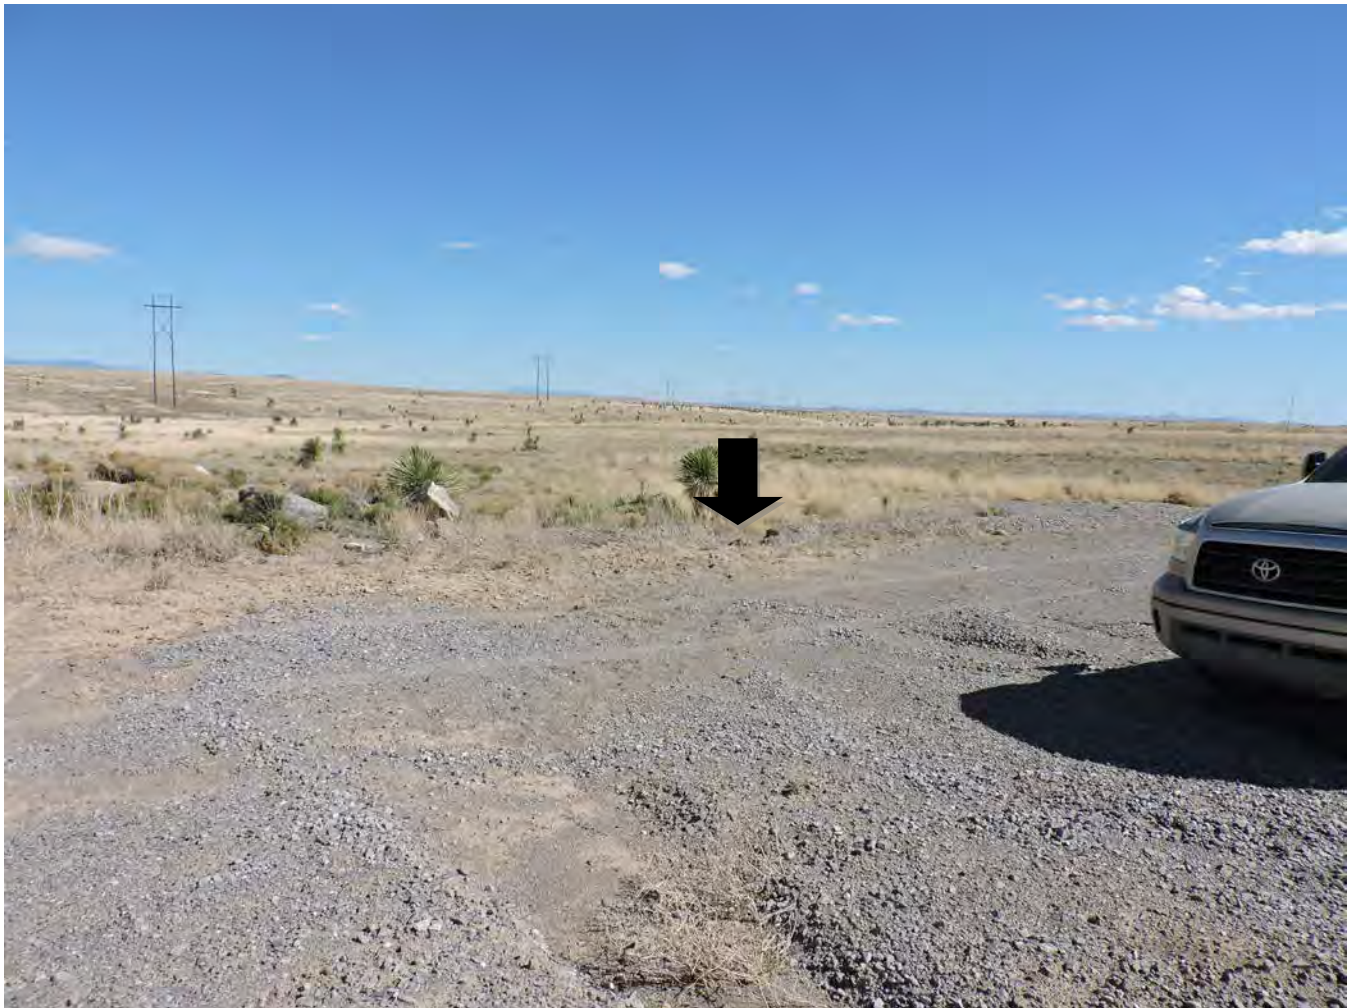
Official Photograph Log
Photo # 13

Photographer: Christian Krueger, FMI	Date: 4-13-16	Time: 1620 hours
City/County: Hurley, Grant County		
Location: Freeport McMoRan, Inc., Chino Mine		
Subject: Berms needing repair at the east end of the quarry. Arrow points to eroded berms.

Currently the major BMP at the quarry is a berm to contain runoff (please see Photo #13). This berm was eroded at the time of this inspection. Sampling results from the 2008 MSGP show that TSS has been an issue from the site. The permittee should evaluate the type of berm to see if there is a better available BMP that will control TSS from the site.

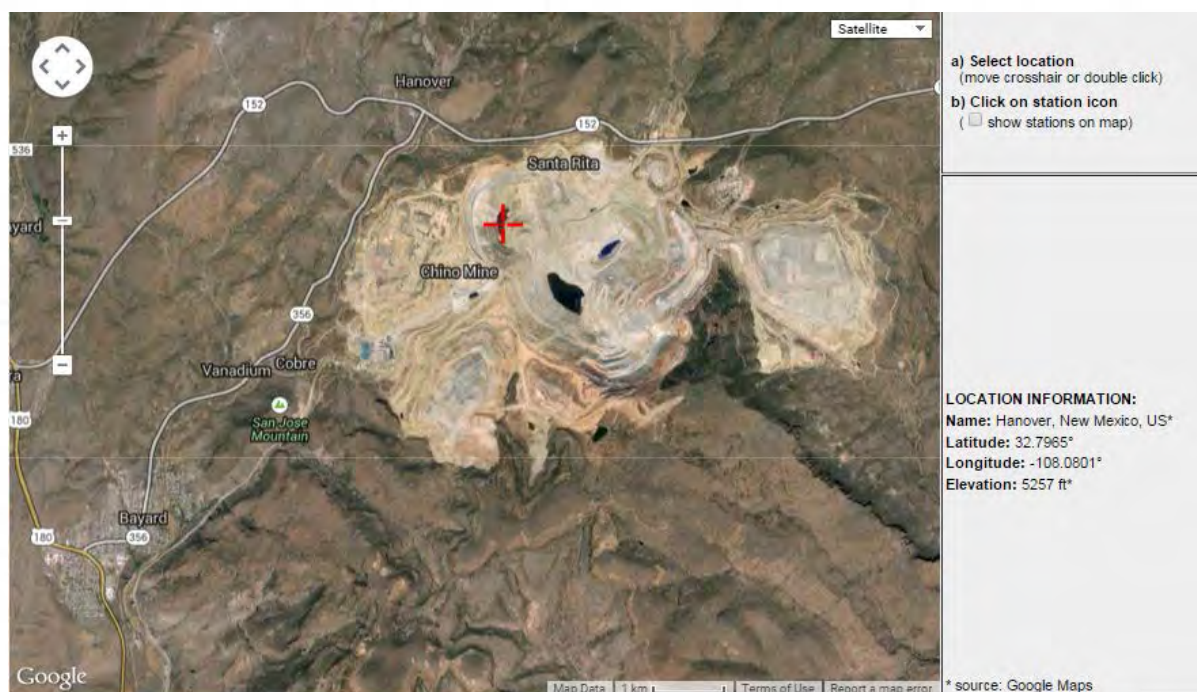
Figure1 – Sample location indicated by red cross-hairs for precipitation data from NOAA

4. Precipitation values vary across the DP areas based on the center of each DP catchment, and values retrieved from the National Oceanic and Atmospheric Administration (NOAA) database (example location shown in Figure 1).
